Single Event Effect Test Report  
on IEEE 1394 Testing at  
Brookhaven National Laboratories and TRIUMF

6/25/01 & 7/12/01

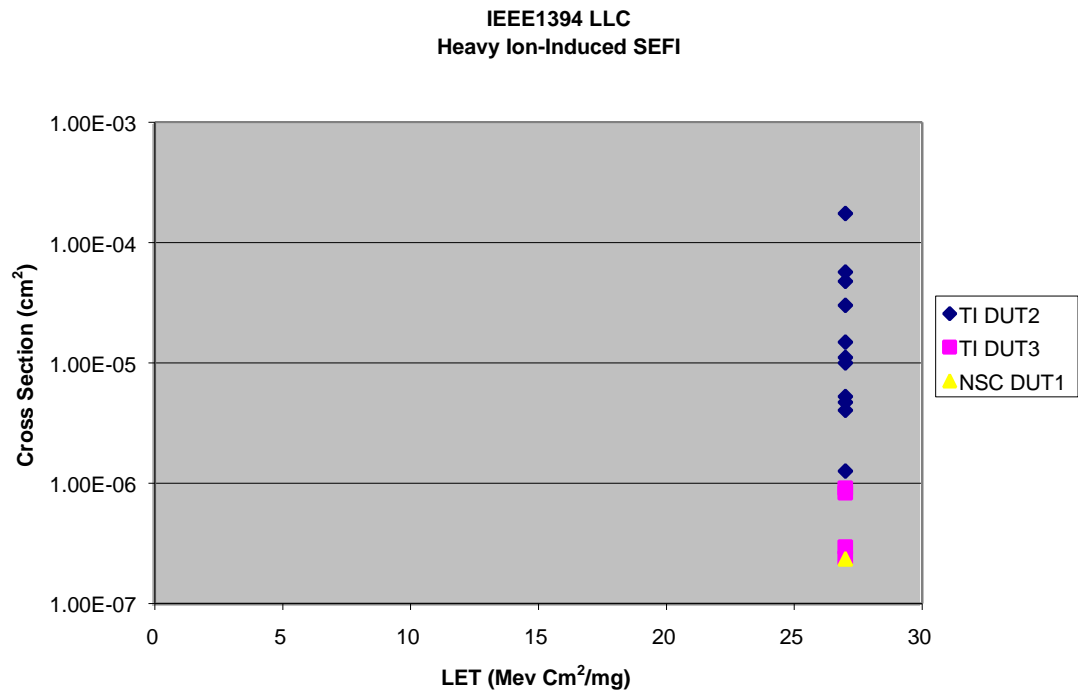
Figure 2: IEEE1394 LLC Heavy Ion-Induced SEFI Cross-Section

Device Number	Device Type	Average SEFI Cross-Section (cm <sup>2</sup> )	Standard Deviation (cm <sup>2</sup> )	Note
TSB12LV26PZT	LLC	2.52E-5	4.70E-5	
CS4210VJG	LLC	2.36E-7	-	Single run. Other runs resulted unrecoverable failures.
TSB41AB3PFP	PHY	5.81E-4	1.02E-2	
CS4103VHG	PHY	3.95E-5	-	Single run. Other runs resulted unrecoverable failures.

Figure 2 plots the cross-section of LLC SEFIs.

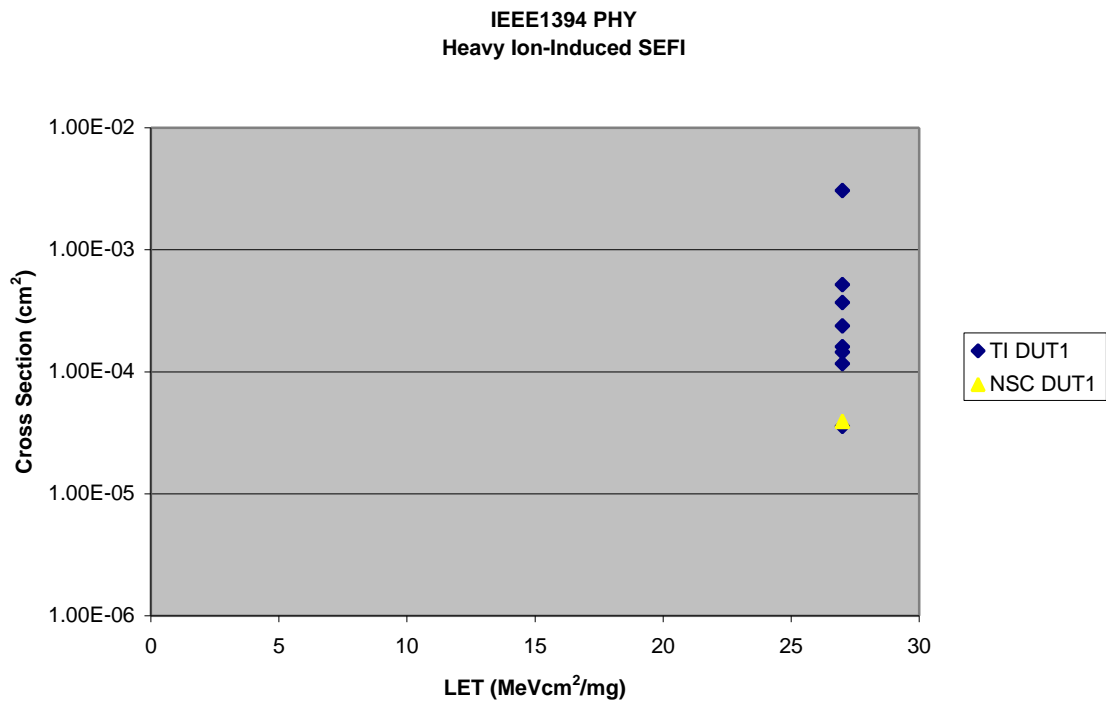
Figure 3: IEEE1394 PHY Heavy Ion-Induced SEFI Cross-Section

Figure 3 plots the cross-section of PHY SEFIs.

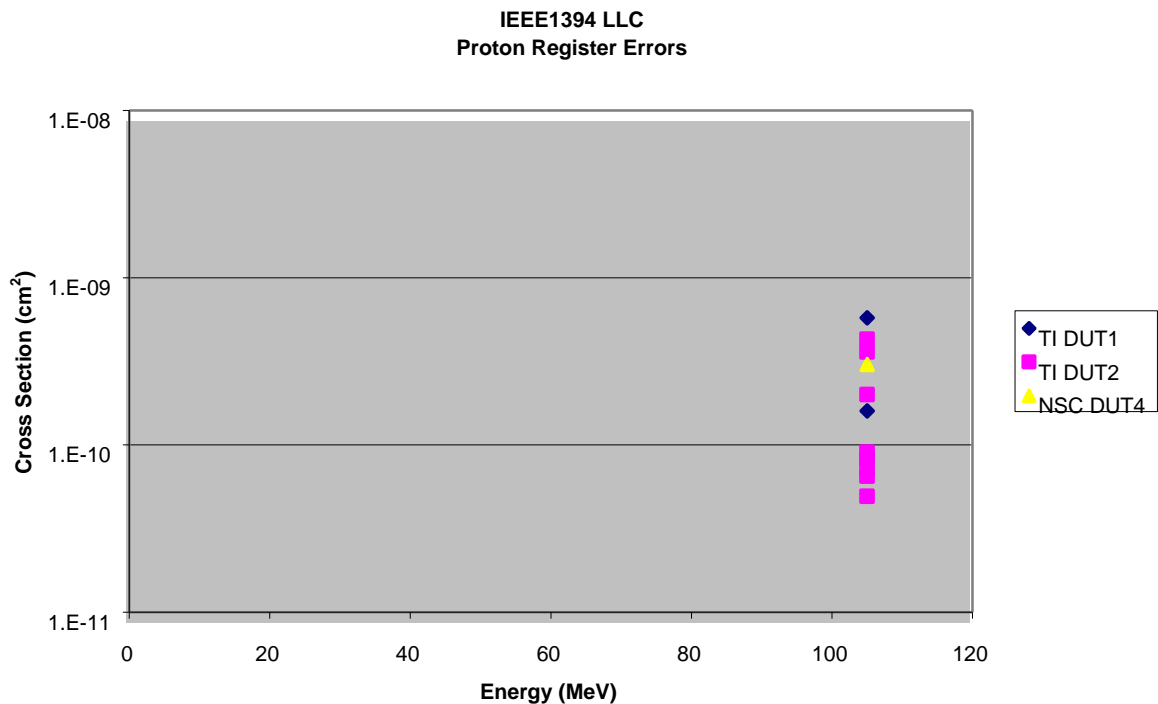
Figure 4: IEEE1394 LLC Register Error Cross-Section

Register testing was broken down into two tests, OHCI/PCI (LLC) and PHY. For the LLC test 42 out of a possible 102 OHCI registers and 21 out of a possible 22 PCI registers were monitored for errors. Errors observed in these registers were single bit in nature. Table 3 shows summary of LLC register errors caused by protons.

Device Number	Device Type	Average SEFI Cross-Section ( $\text{cm}^2$ )	Standard Deviation ( $\text{cm}^2$ )	Note
TSB12LV26PZT	LLC	1.88E-10	1.73E-10	
CS4210VJG	LLC	3.04E-10	-	Single run with register errors

Figure 4 shows the SEU cross-section of LLC register errors.

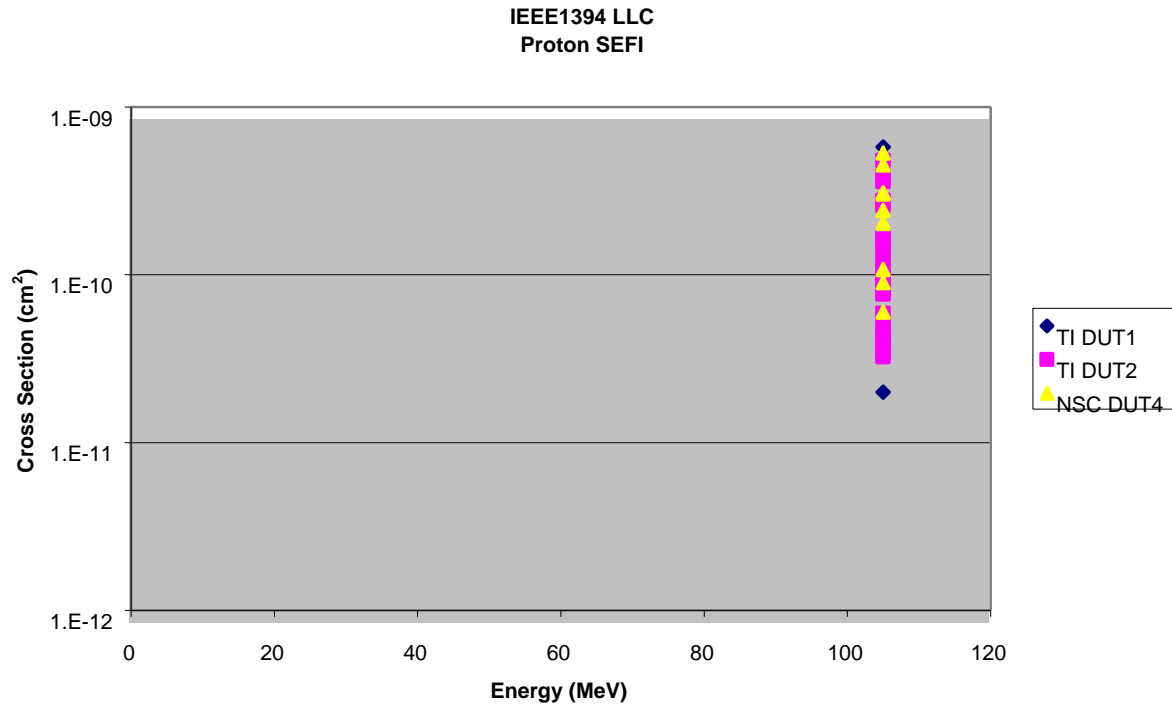
Figure 5: IEEE1394 LLC Proton-Induced SEFI Cross-Section

Device Number	Device Type	Average SEFI Cross-Section (cm <sup>2</sup> )	Standard Deviation (cm <sup>2</sup> )	Note
TSB12LV26PZT	LLC	1.48E-10	1.45E-10	
CS4210VJG	LLC	2.56E-10	1.63E-10	
TSB41AB3PFP	PHY	5.98E-11	5.96E-11	One incident of FAT corruption
CS4103VHG	PHY	1.46E-10	1.09E-10	>1 Amp current consumption

Figure 5 and Figure 6 depict LLC SEFI cross-section and PHY SEFI cross-section respectively.
